Transport
Canada

TP 6980E

**AGING
AIRCRAFT
Part IV**

Canadian Aviation Service Difficulty Reports

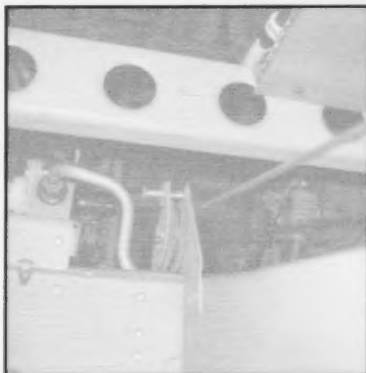
SDR # 20041123001

Pulley Spring Pin Shifted

The primary cable for the elevator control had jumped out of its respective pulley. The "spring pin", P/N NAS 427K6, that prevents this from happening was out of position, and therefore was unable to stop the cable from leaving the pulley.

This defect subsequently caused abrasion of the elevator cable on the surrounding support structure. The support structure is a short distance from where the elevator cable emerges from the pressure vessel as it travels aft to the bellcrank.

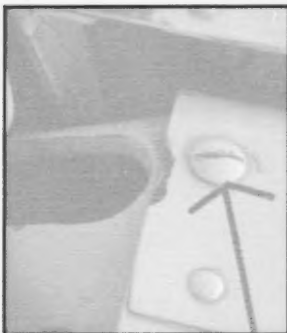
SDR # 20050127002

Elevator Horn Cracked

The operator noted that the elevator skin at the control horn attach point was cracked. Further inspection of the control horn assembly, P/N 956100054, revealed a 1-inch crack emanating from one of four-elevator horn mounting bolts. The elevator control fitting was replaced.

The submitter carried out a fleet inspection using visual and eddy current inspection and no further defects were found. Transport Canada reminds maintainers to be vigilant while inspecting this area. ✖

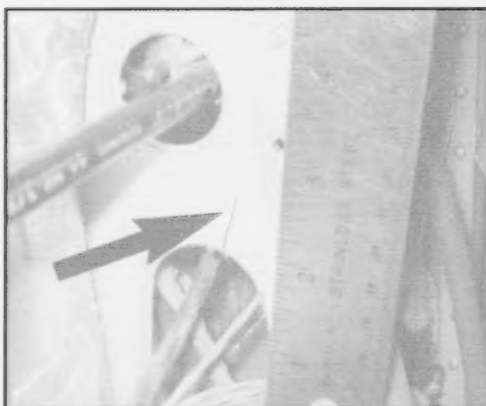
SDR # 20050117001

Frame Structure Cracked

During a routine inspection, a crack was found propagating from an oval hole in the right hand frame at station 207.125, half way between the floor and the window. The crack was approximately 1½ inches long and extended from the eleven o'clock position of the lightening hole to a rivet on the reinforcement plate.

Transport Canada reminds maintainers to keep this defect in mind while inspecting this area and other manufacturing lightening holes for cracks.

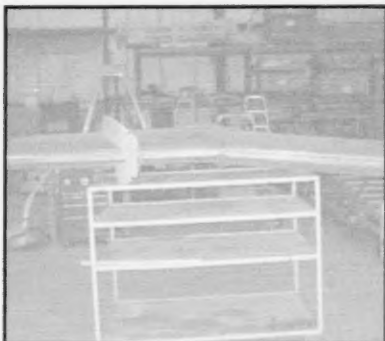
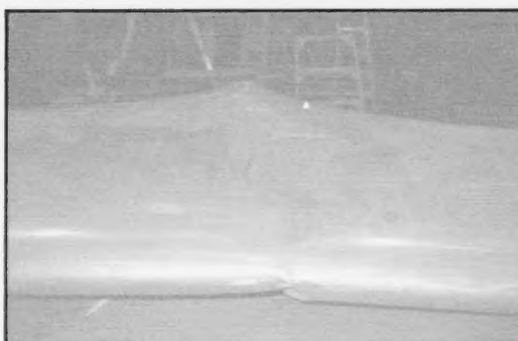
SDR # 20040913007

Slat Actuator Failed

During departure, the crew observed a continuous slat indication problem. The aircraft returned to the airport and made an uneventful landing.

Maintenance personnel investigated and found that the #5 slat rod end bearing had separated from the piston and caused damage to the slat.

The actuator and slat assembly was replaced and the aircraft was returned to service. The submitter stated that the rod end bearing was enclosed in a shrink sleeve and this may have hidden the impending failure of the rod end.

An air operator fleet campaign inspection has been initiated on the remaining aircraft.

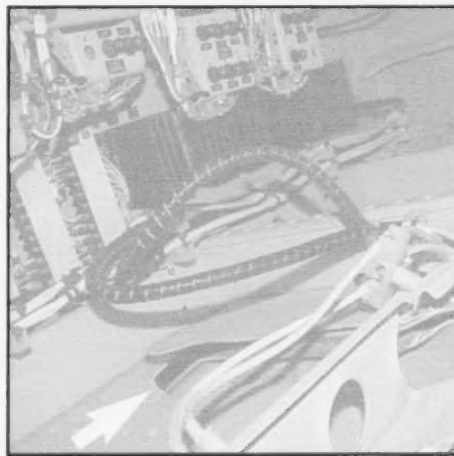
Nose Landing Gear Assistor Spring Assembly Failed

Shortly after departure and during landing gear retraction, the crew heard a loud noise under the flight deck. Following landing, an inspection of the nose landing gear area and wheel well area was carried out. It was then discovered that the nose landing gear assistor spring, P/N HC323L0001000, had failed.

Further investigation revealed that the broken assistor spring had punctured a hole, approximately 8" by 12" in size, through the floor of the flight deck.

The cause of these events appears to be a lack of lubrication and metal fatigue.

Damage caused by broken assistor spring

The damage was repaired and the aircraft was returned to service. A fleet inspection revealed that one other aircraft had significant cracking on both internal tube assemblies. The tube was cracked almost entirely around its circumference. Both of these aircraft had logged approximately 32 000 cycles.

Transport Canada recommends that maintenance personnel pay particular attention to this area. ✖

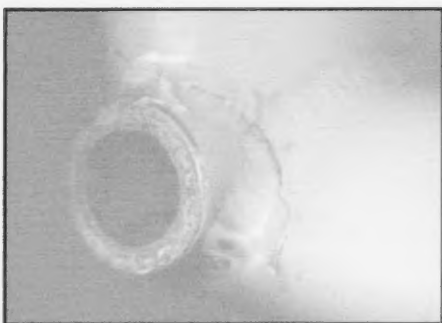
SDR # 20050201002

Engine Mount Ring Cracked

During routine maintenance, the engine mount ring (horse collar) was found cracked at two of the four attachment points. An additional task card, initiated in 1999, to check for this condition every 100 hours, was added to our maintenance schedule, and, as a result, we have discovered the condition on 12 separate collars. The collar was replaced and the aircraft released.

This problem has been around for sometime and is traced back to faulty shimmy dampers. Close inspection of the horse collar should be carried out periodically particularly when the aircraft has experienced a nose wheel shimmy problem. FAA AD 90-05-04 is available to operators at:

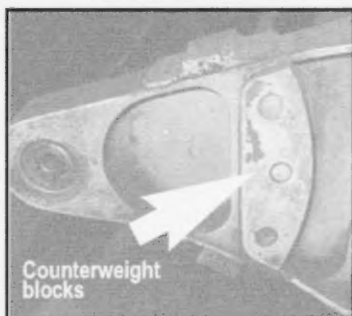
SDR # 20050224007

Counterweight Block Corrosion

While inspecting the centre hinge bracket of the horizontal stabilizer for cracks, as per Manufacturer's Service Bulletin 6/512, corrosion was found under the counterweight block, P/N C6TP1026-27, and was visible on the surface surrounding the block. When the blocks were removed for further inspection, exfoliation corrosion was found under both sides.

The operator took the initiative to investigate the visible corrosion found during his inspection of the centre hinge bracket. In doing so, he uncovered corrosion to be of significant enough nature (Level 3), which required replacement of the part. ✖

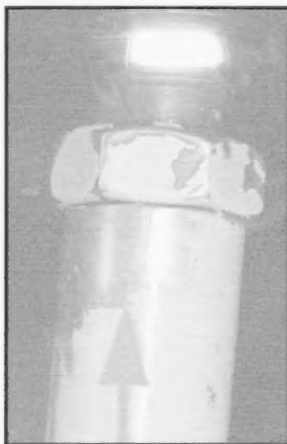
SDR # 20041223005

Pitch Link Cracks

During a scheduled 100-hour inspection, an operator discovered two (2) vertical cracks on a main rotor pitch link. The cracks discovered were approximately .180 inches in length.

Transport Canada reminds AMEs of the importance of the inspection of the pitch links and a reminder that these cracks can occur. ✂

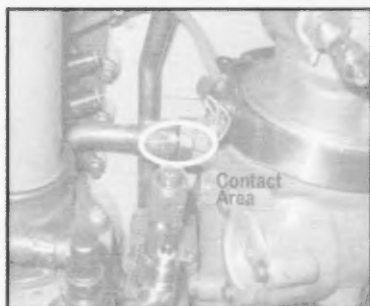
SDR # 20041119008

Primary Fuel Manifold Feed Line Damaged

During a scheduled oil pump replacement, severe wear was found on the primary fuel manifold feed line located near the fuel flow transmitter. Due to a lack of clearance, contact between the fuel flow transmitter inlet "B" nut and the feed lines caused the damage.

Most of this damage was caused by the cutting action of the "B" nut as it was tightened during installation of the fuel flow transmitter, which had been removed some time earlier for engine overhaul. Two of the three engines on this aircraft had similar damage.

It is possible that maintenance personnel caused this damage during installation. Falcon 900 maintainers should carry out a visual check in this area for chafed or damaged fuel lines. ✖

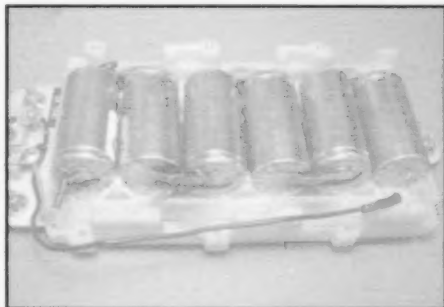
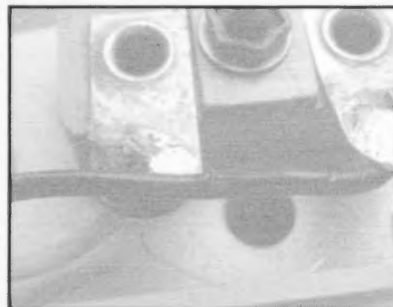
Battery Pack Assembly Failed

The emergency light battery pack, P/N 6104781, was removed due to inoperative emergency lights at the ceiling first three positions.

During overhaul of the battery pack, it was found that the pack had shorted out. It appears that during the last cell replacement, the connection leads were cut too short, which prevented the correct routing of the wires. When the pack was installed on the aircraft, the wires became pinched and the pack shorted out. The pack was installed one month prior to the failure.

This battery pack is installed in several different aircraft models and has been in existence for many years. Transport Canada reminds AMO's that these battery packs need to perform when required. Proper overhaul and assembly is critical for reliability. ✂
